Thumping Sounds in the Closet

By Dranetz-BMI

Elevator control panels for the lower zone mid-rise elevators were on the nineteenth floor of a forty story office building in a large midwestern city. It was fed with 480V transformer on the same floor, with the feeders to the controls rated at 800A.

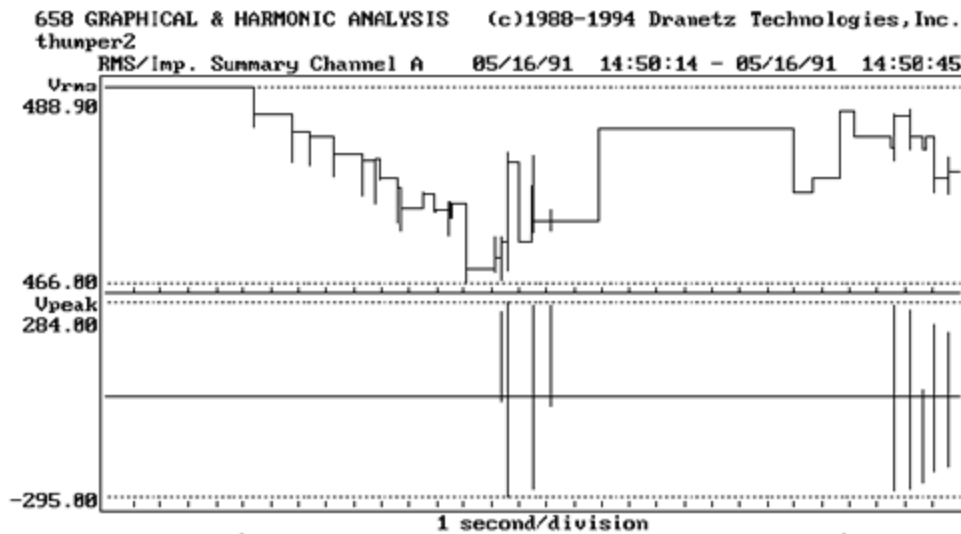
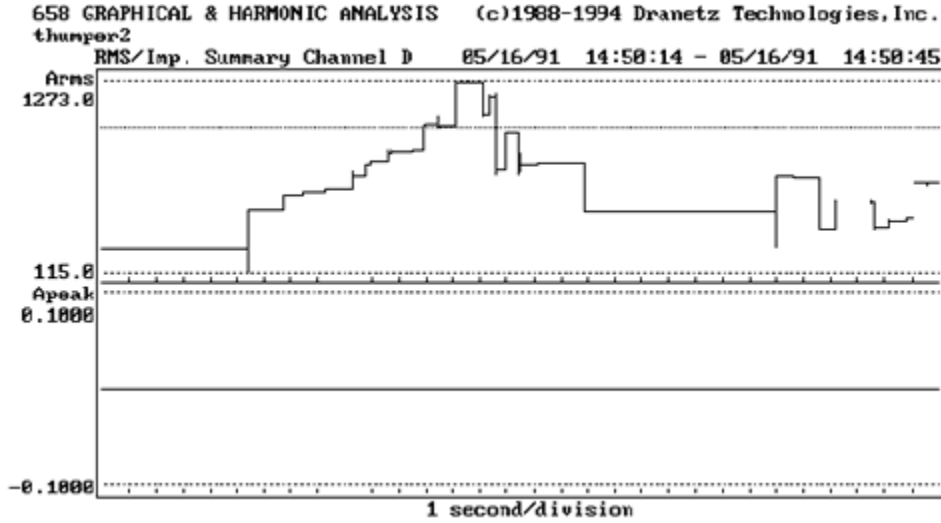
Monitoring was done on at the service panels on the 19th, 25th and 37th floors. Different combinations of the three voltages and three currents were monitored for only a short duration before the source of the problem became evident. *Figure 1* and *2* below show the time plot of voltage and current, respectively, on one phase, which were representative of all of the phases.

As the current values increase, a corresponding decrease in the RMS level of the voltage is observed. The maximum current is over 1200A on the 800A service.

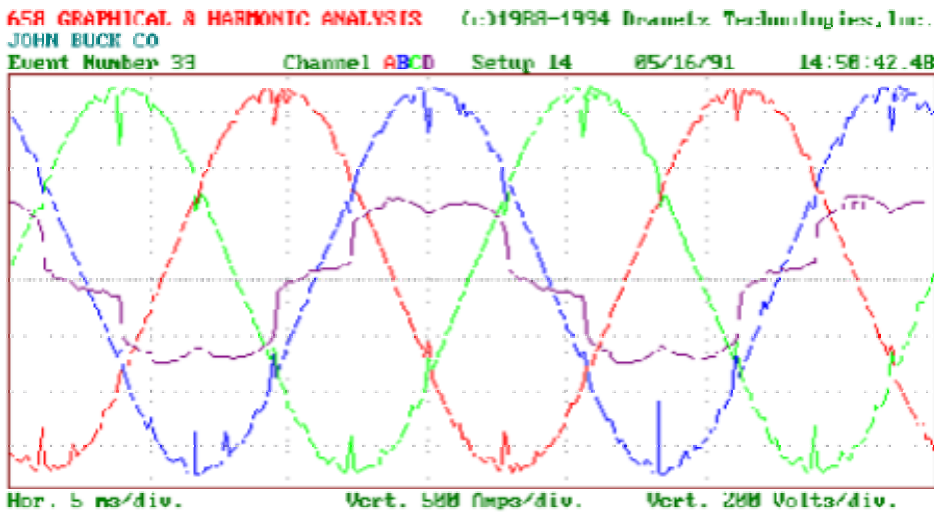
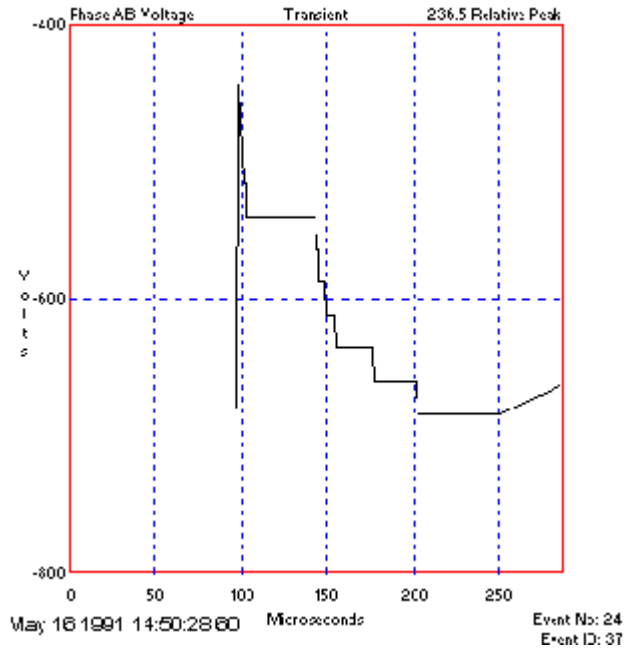
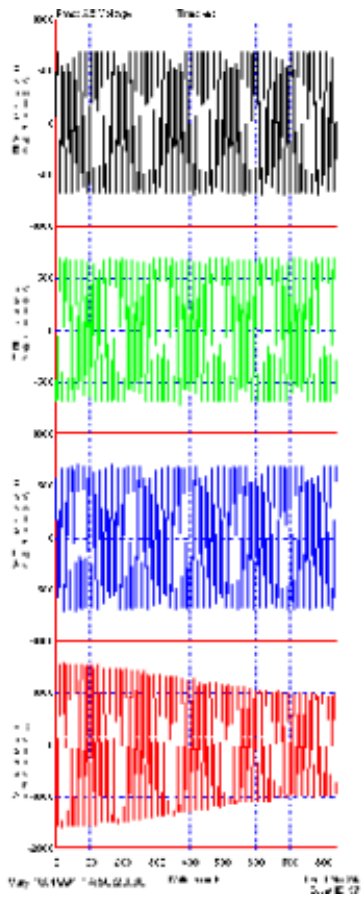
The voltage transients during this 40 second window were nearly 300V. Closer examination of these transients can be seen in Figure 3 and 4. Notice how the voltage notches appear in the same position on the wave of each of the phases.

Voltage notches were the most prevalent type of event observed. As noted, these occurred at the same phase position on all phases and corresponding to the current waveform. A one second monitoring period noted 3026 such notches, with a worst notch area of 0.42159 volt-seconds. The depth of the notch was most severe on the

voltage phase corresponding to the current phase that had the step change in current.

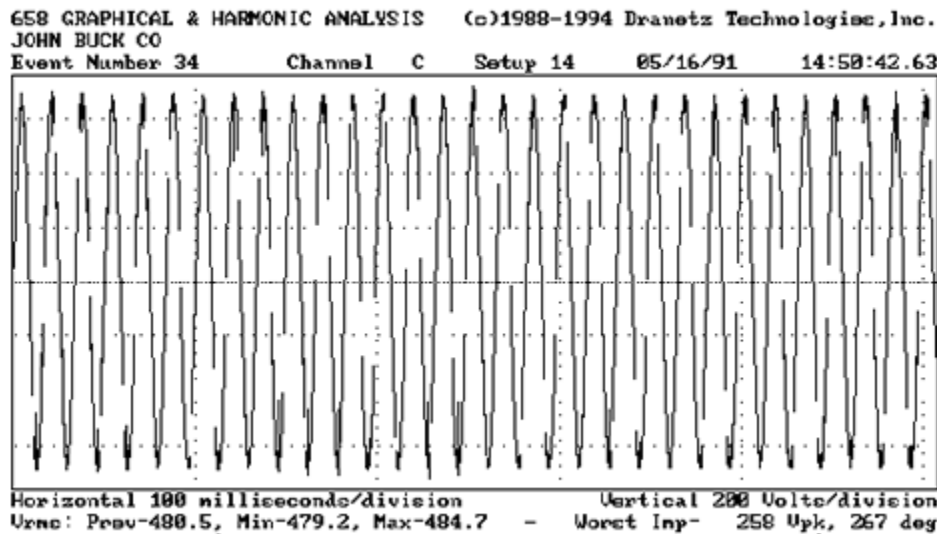
The overall RMS voltage values were observed to be fluctuating. Such fluctuations often result in light flicker, though none was reported at this location. Figures 5 and 6 shows the voltage fluctuations and the current during the startup of an elevator.

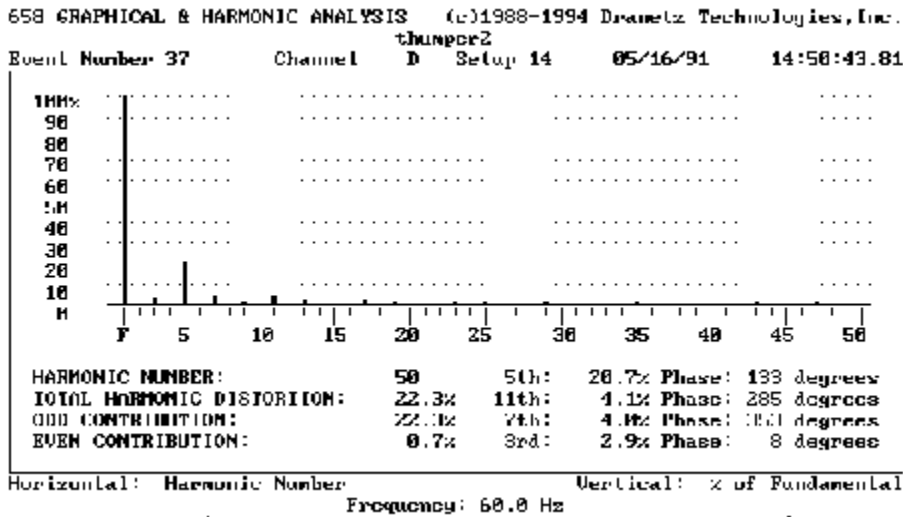
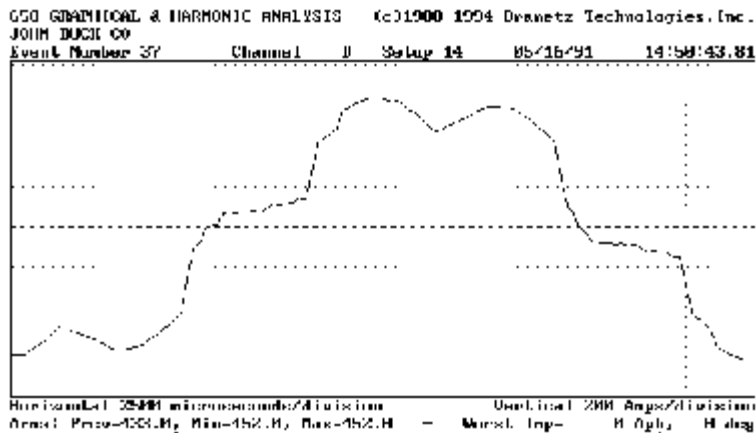
The voltage channels' total harmonic distortion was typically under 4%, varying under different loading. The fifth harmonic was the predominate one, at 2.4%. This corresponded to the current harmonics, as shown in Figure 8 for the current waveform in Figure 7.
