Infrared inspections are a routine inspection in all areas of our plants.

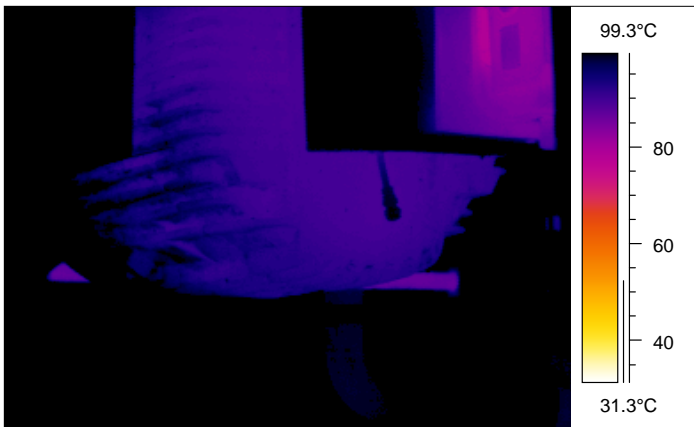
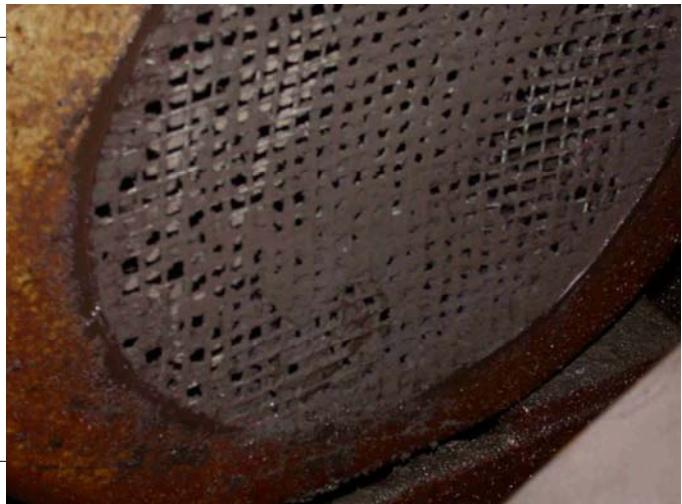
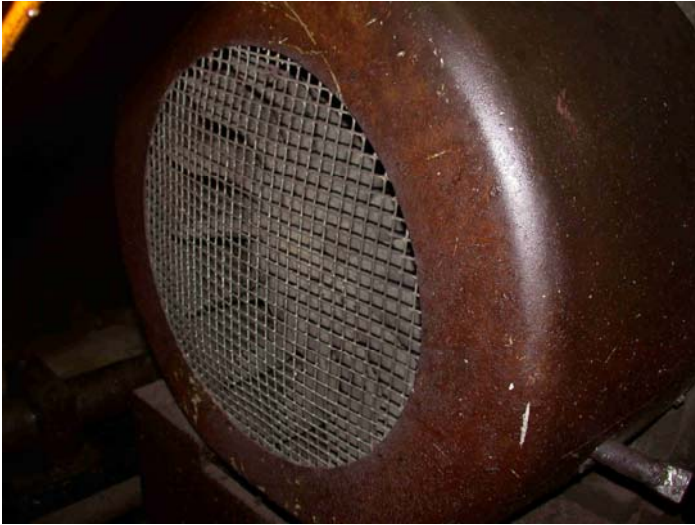
What we have here are some images captured on regular rounds, this is a motor that was running extremely hot, over 100 deg C, it was discovered that all of the motors were running this hot, it was unusual. The thermographer found the source of the problem by just looking around; the end bells for the fans were plugged with grease and dirt. Once cleaned all of the motor's operating temperatures dropped to normal levels of around 40 deg C. See attached.

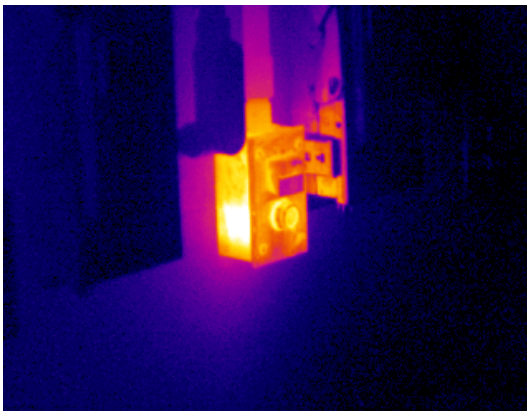
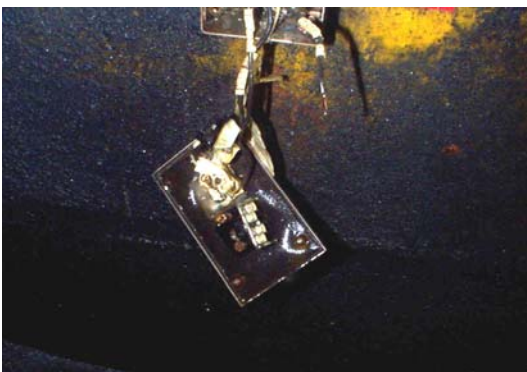
Other things found on routine rounds were an emergency stop Pushbutton station that was at over 100 deg C, water had entered the box and shorted the leads and melted the pushbutton down. This effectively eliminated the redundant spare pump motor from starting, not to mention the hot steam from burning someone who opened the box to see what the problem was. With the infrared images at hand the electrician opened the box cautiously, when he did steam billowed out of the box, this possibly eliminated a possible burn to the electricians hand.

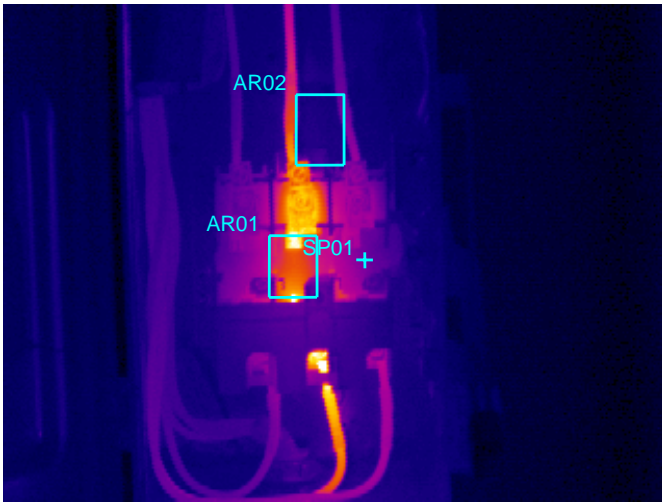
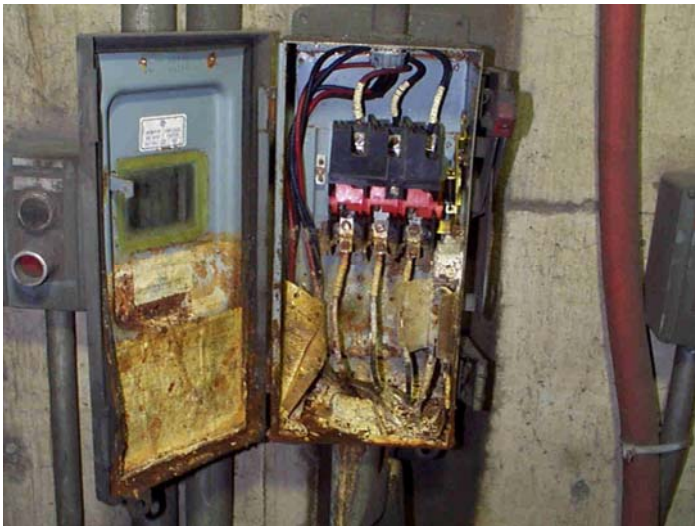
The other set of eyes will also notice damage like this water damage inside a local disconnect that had several hot connections.
