Case History
Blower Motor
125 HP
480 VAC 3 Phase

Brass Tag # 02845
Maintenance Reliability Dept.
Jim Zuidema

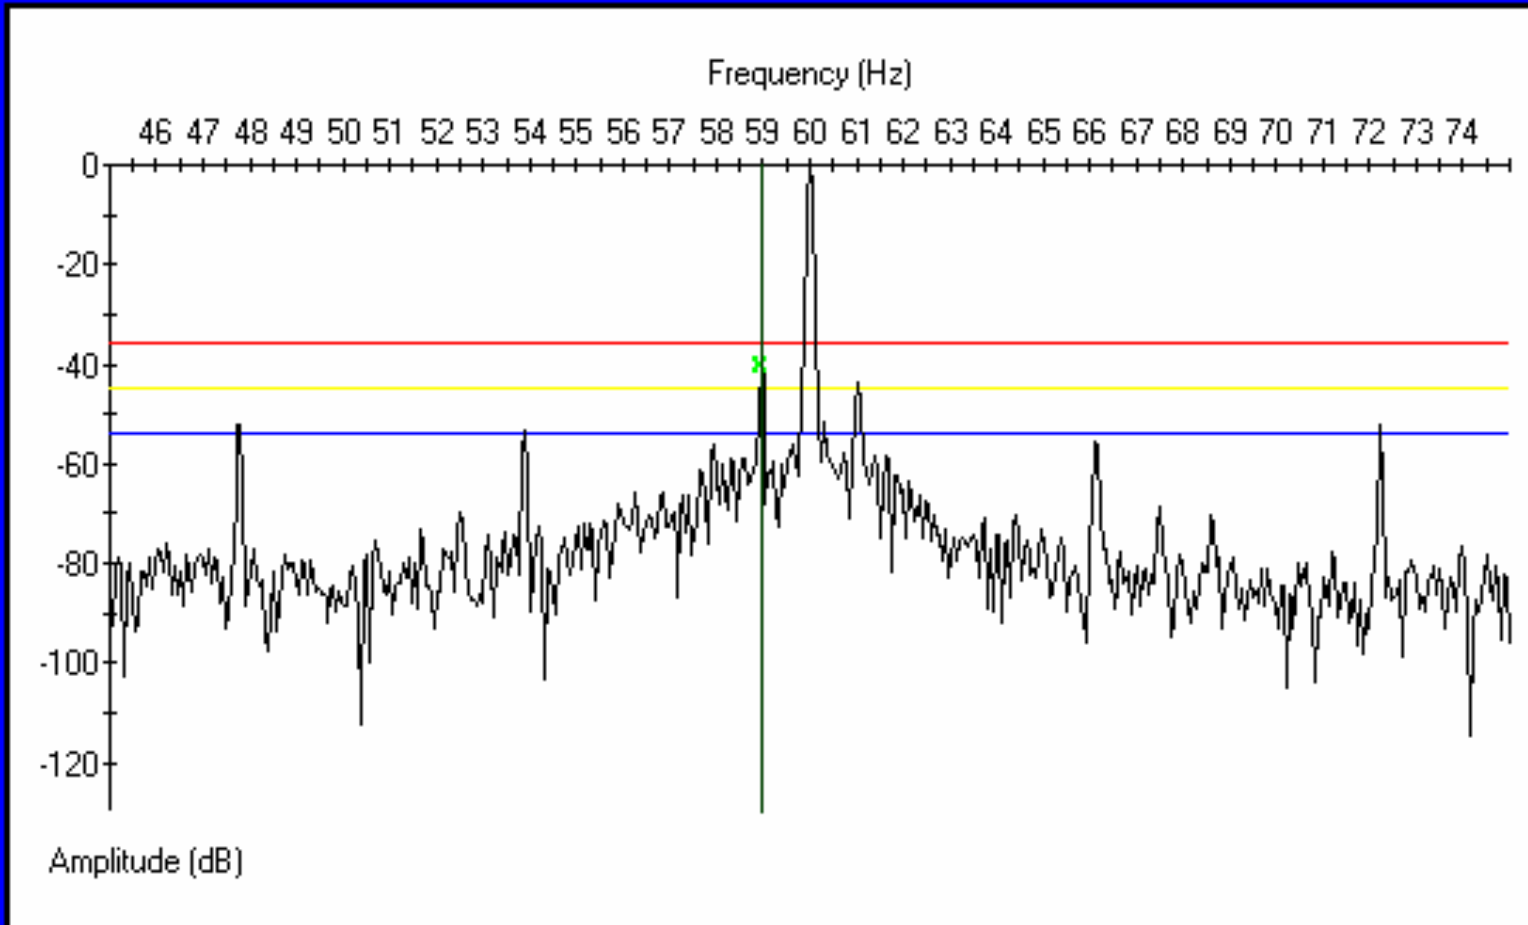
The green X marks the spot for a rotor bar problem when using PdMA MCE Emax Online current signature analysis, in this case about -41 db

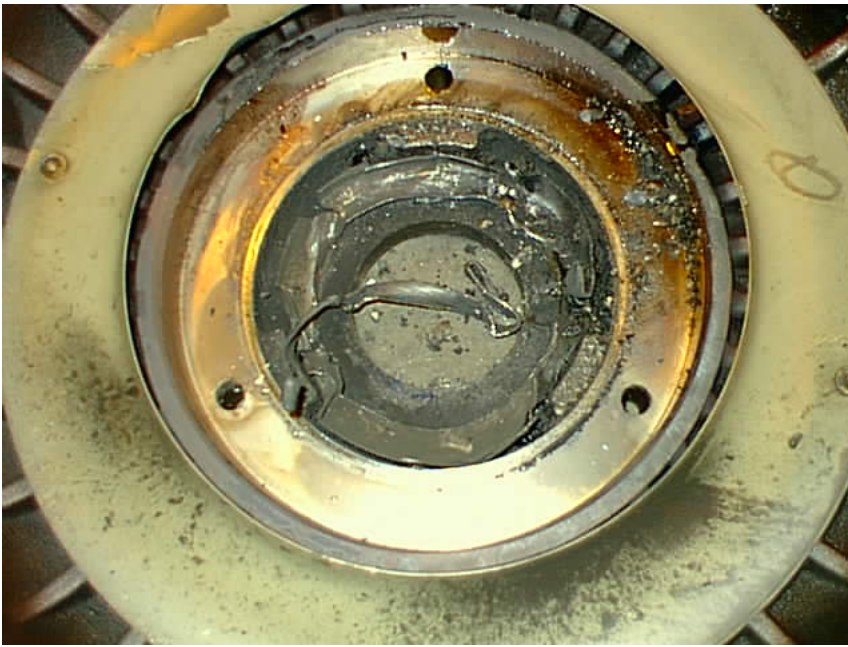
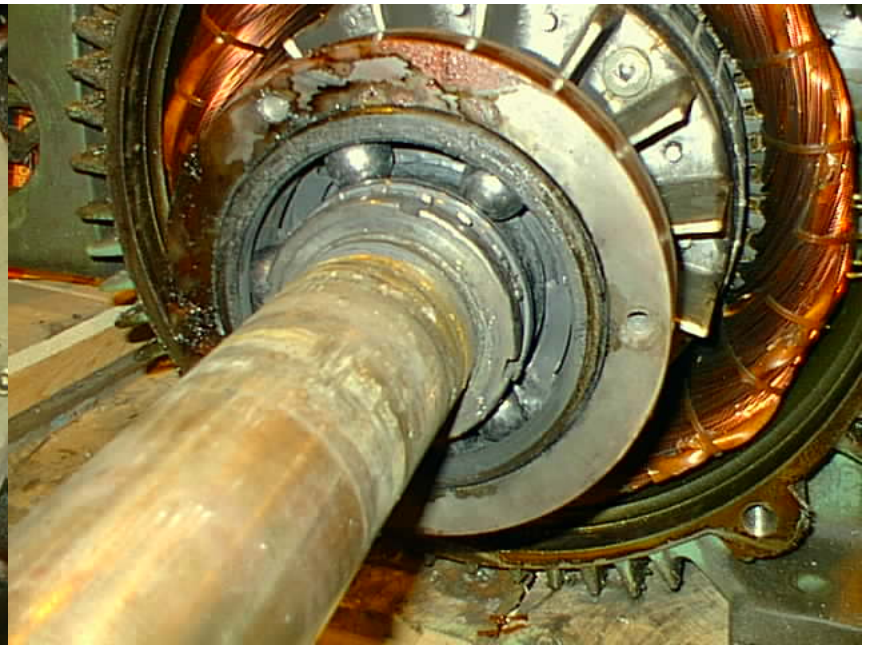
Motor removed due to DE bearing failure 3/17/2003

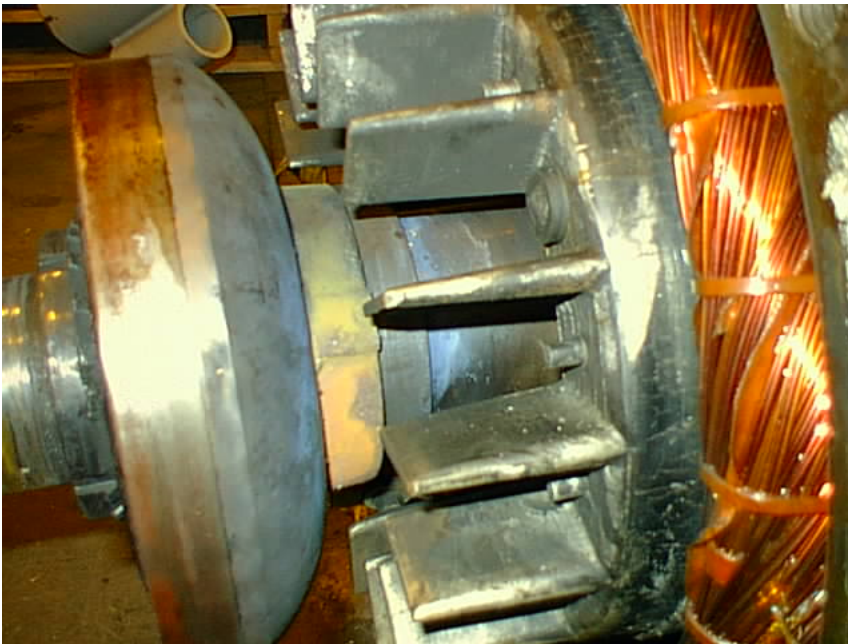
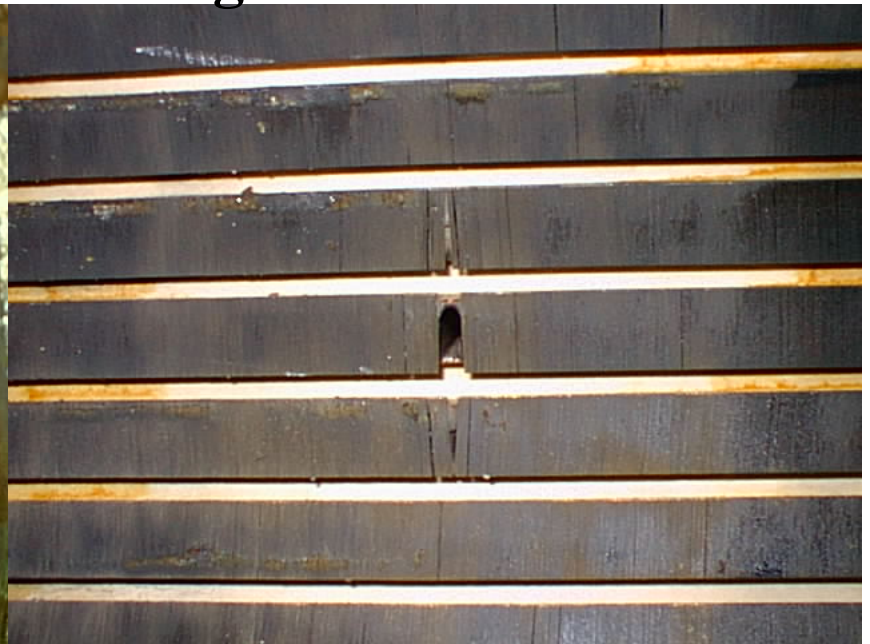
The rotor was core loss tested
with an obvious hot spot

A 3” wide slice was cut from the
the rotor for further analysis

- Our local non destructive ultrasonic metal inspection department located anomalies in the area of the hot spot found by the core loss test.

A pie shaped cross section was cut from the 3” slice of the rotor for further inspection.

Laminations were then removed one at a time to reveal the suspected problem.

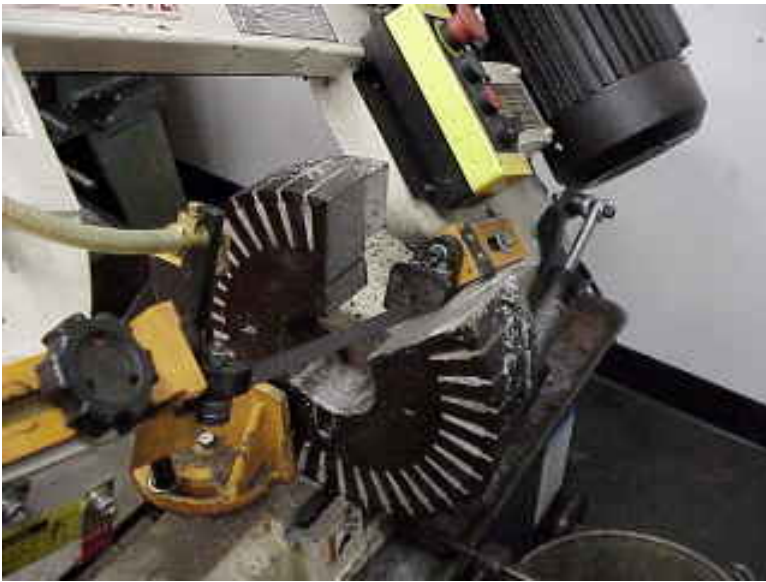
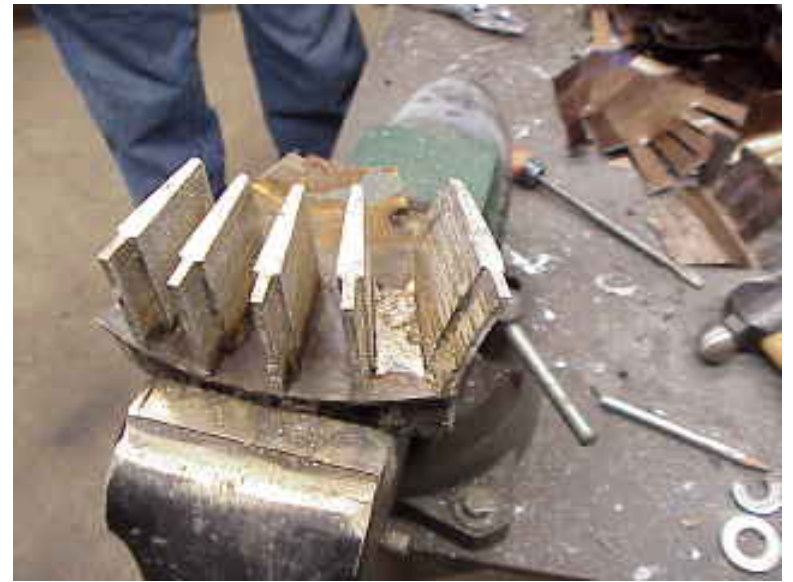
With 4 laminations left we noted aluminum between them and a wobbly rotor bar!

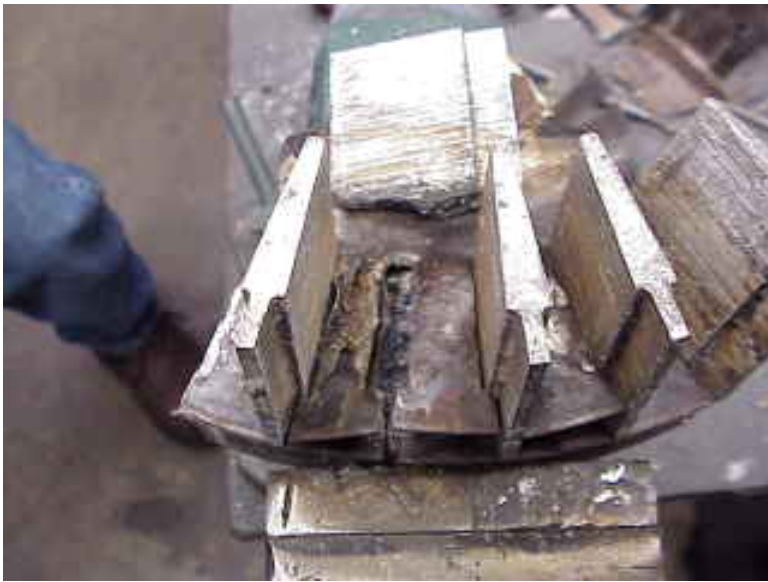
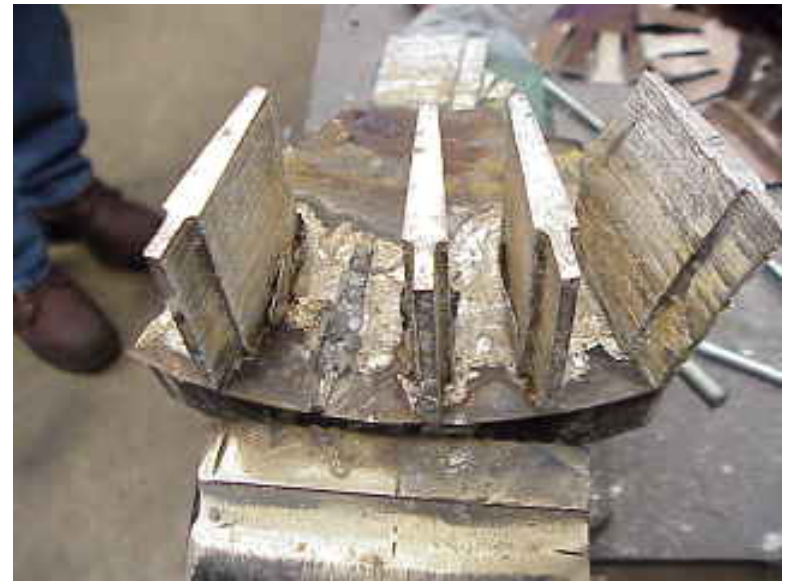
Walla, broken rotor bar, obviously!
PdMA was right on the money.

Because this motor had a known defect, it was not repaired but replaced, saving future expenses and down time that most likely would have been caused by this motor, had it been repaired and put back in service.
