## Vertical Condensate Pump Alignment

*By Alan Luedeking, Ludeca, Inc., Miami, FL*

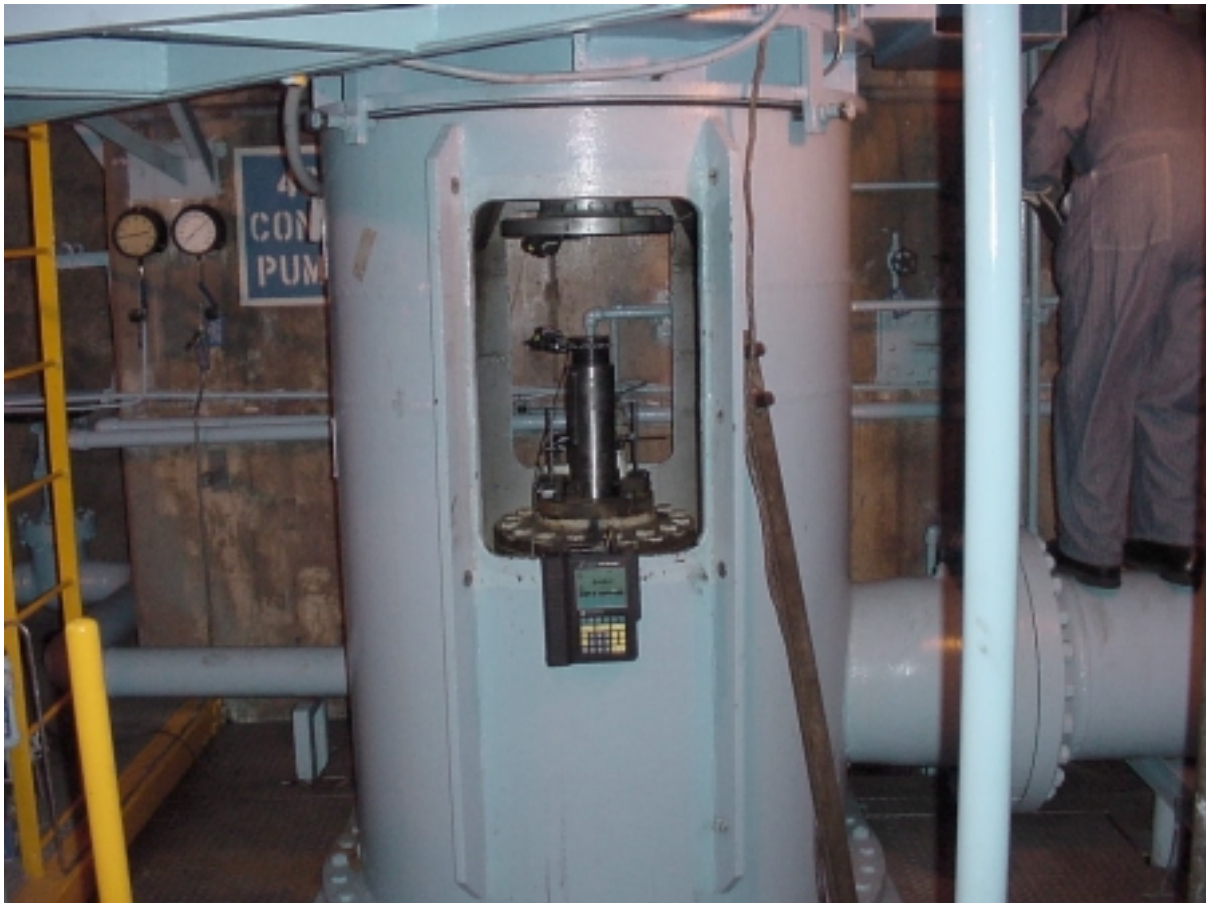
Figure 1

The shaft alignment of large vertical condensate pumps in power plants is a challenging application. The pump shaft and impeller are rigidly coupled to the vertical flange-mounted motor. The rigid or solid coupling makes taking meaningful alignment measurements virtually impossible. When this coupling is left connected (and tightened), misalignment cannot be measured conventionally (by rotating both coupled shafts), because no relative movement between the shafts is allowed to occur, as would be the case with a flexible coupling. Instead, the solid coupling makes a rigid connection between the shafts, resulting in deflection of the shafts if misalignment exists. Angular misalignment between the centerlines of rotation is often evidenced by excessive vibration and wear at the first guide bearing of the pump shaft. If the coupling is completely disconnected, the pump shaft settles on the bottom of the pump pit and may be impossible to turn, even if (as is done occasionally) it rests on a specially fitted conical seat to assist in controlling pump shaft play at the bottom of the shaft. How to overcome these difficulties and properly measure, as well as correct, the misalignment?

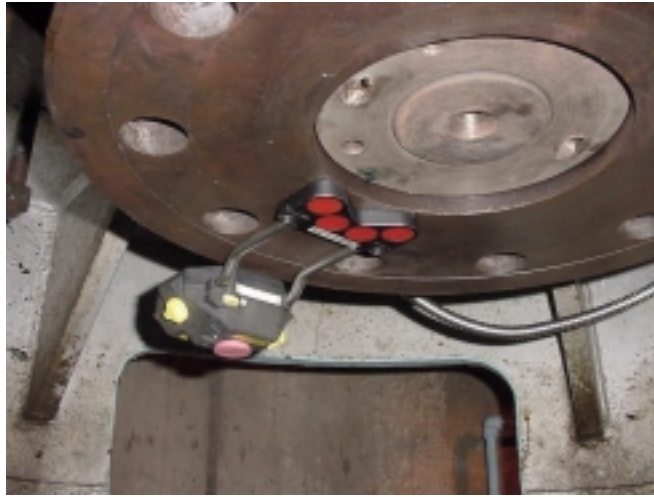
Figure2

Since the pump shaft can not be turned when uncoupled and resting on the bottom, the laser readings were taken using the 'Static' measurement mode, which is a process that permits a reading to be taken in any cardinal or subcardinal position. Additionally, this mode disables the internal automatic inclinometer, which is necessary in a vertical shaft orientation, as the inclinometer is gravity operated. The laser and receiver components are rotated separately. Since the motor shaft can be rotated freely, the laser emitter was installed on this shaft. This was done by attaching a magnetic bracket with offset support posts to the face of the rigid motor coupling, as shown in Figure 2.

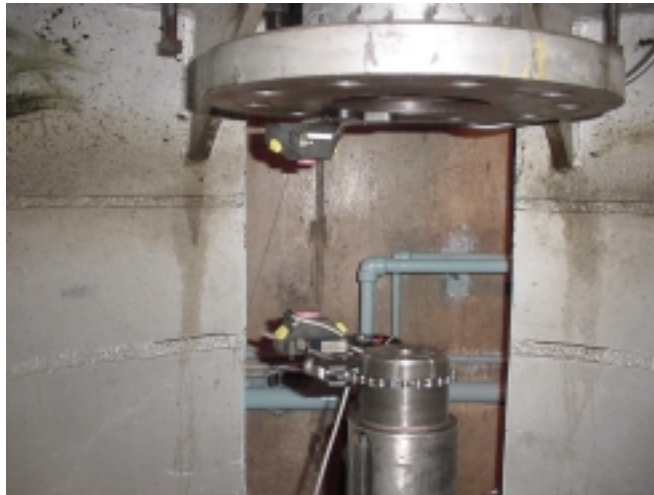
Figure 3

The receiver is to be mounted on the pump shaft, normally using a special magnetic sliding bracket, since the pump shaft cannot be turned. However, in this case a non-magnetic shaft prevented this, so the standard chain bracket was used, as shown in Figure 3. Care was taken not to hurt the threads on the shaft. The laser beam was adjusted and an initial reading was taken.

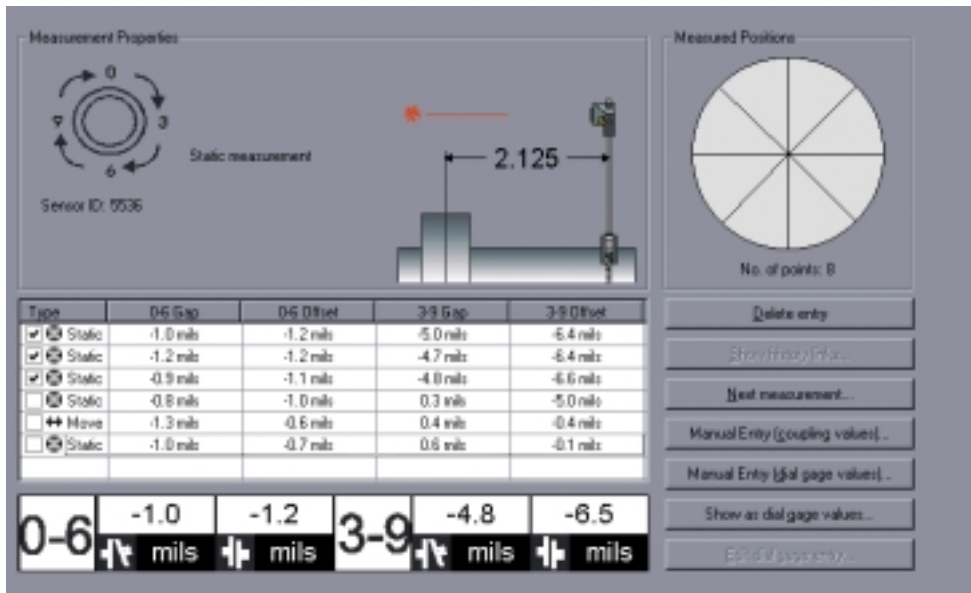
Next, the motor shaft with laser emitter was rotated to a new position, the receiver bracket was rotated to the same position, and another reading was taken. This sequence was repeated until eight readings were taken. Three readings are sufficient to obtain results, however, the more the better. Alignment results were now obtained and the entire measurement process was repeated to obtain a second set of results. This is done to establish repeatability. The results can be averaged together if desired, as shown at the bottom of the measurement table in Figure 4. In this case, three sets of readings were averaged together (as indicated by the checkmarks in the first three lines of the measure table.)

Repeatability was found to be very good, and angularity was found to be out of tolerance in the 3 to 9 o'clock direction. This meant that the motor flange would have to be shimmed at the hold-down bolts. A graphical representation, to scale, of the alignment condition was also provided by the ROTALIGN® PRO, as shown in Figure 5:

Once the shimming was completed, alignment readings were retaken to confirm that the angularity was now within tolerance. The Measure Table in Figure 4 presents a documentary history of the events as they occurred in this alignment job. The fourth line in the table shows the measured alignment result after the shimming corrections were carried out to correct the angularity. It can be seen that angularity was now excellent but that an offset correction was still necessary in the 3 to 9 o'clock direction. If offset misalignment between the shafts is out of tolerance, corrections are performed by pushing the motor laterally with jackscrews. This movement can be monitored using the ROTALIGN® PRO's Move function, or with dial indicators positioned radially against the motor flange. The fifth line shows the results of the move that was performed using the ROTALIGN® PRO's Move function. Lastly, a final set of readings was taken to confirm the results of the move and document the 'as left' alignment condition.

The motor was quickly and successfully aligned, attaining a final alignment result that fell within the excellent tolerance standard for the speed of rotation involved, as shown in the sixth line of the Measure Table in Figure 4, and by the results graph in Figure 8:

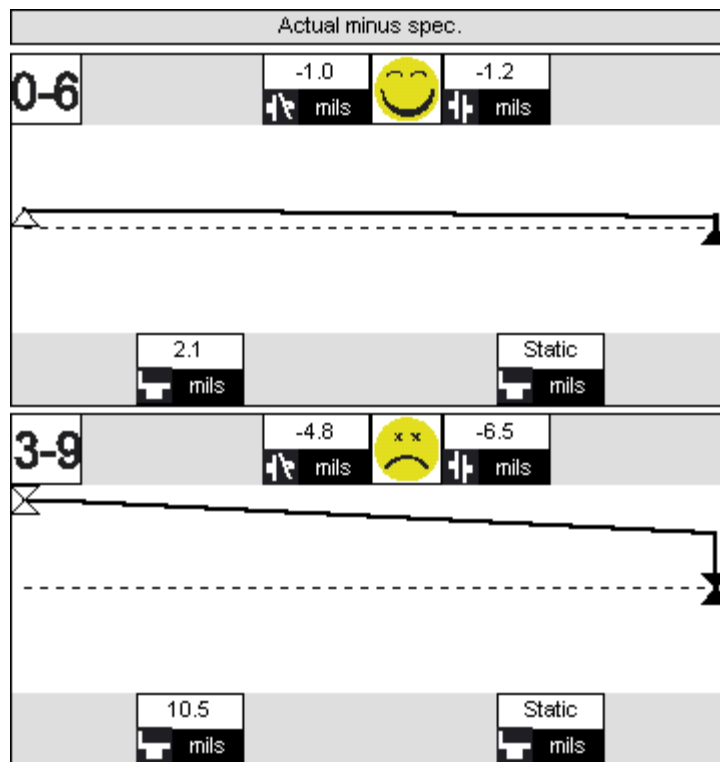
Figure 5

The “smiling” or “sad” faces indicate whether the displayed alignment condition fell within tolerances or not, for the RPM involved. The ideal shimming solution for the motor flange is one where half of the corrections are positive and half of them are

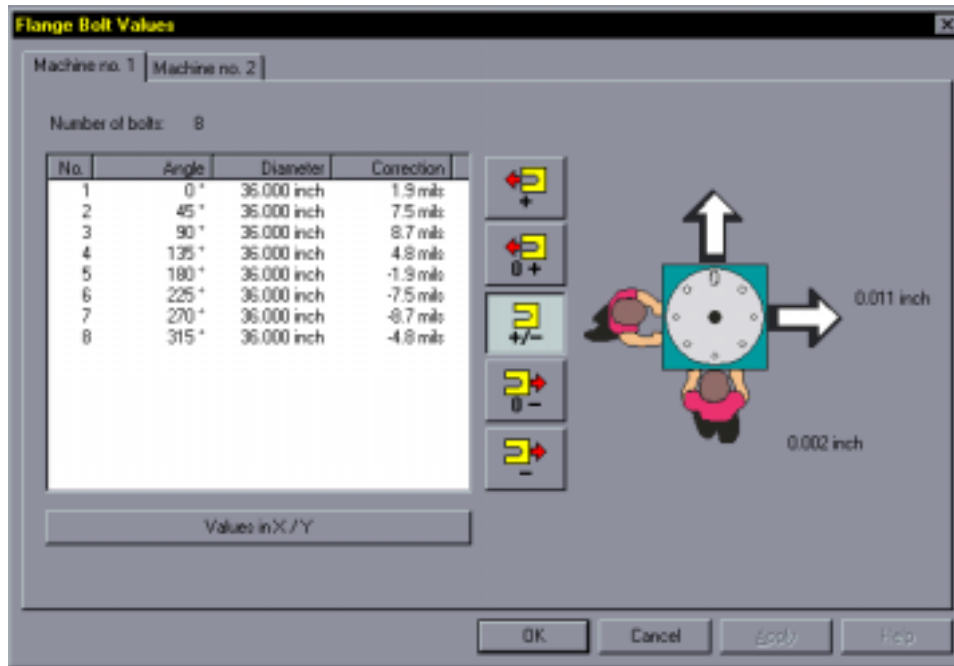
Figure 6

negative, so as to avoid the undesirable axial movement of the pump shaft discussed earlier. This ideal solution was provided by the ROTALIGN® PRO, which additionally possesses a capability to supply all positive or negative flange-shimming solutions, as well as minimized shimming solutions. The results are shown in Figure 6:

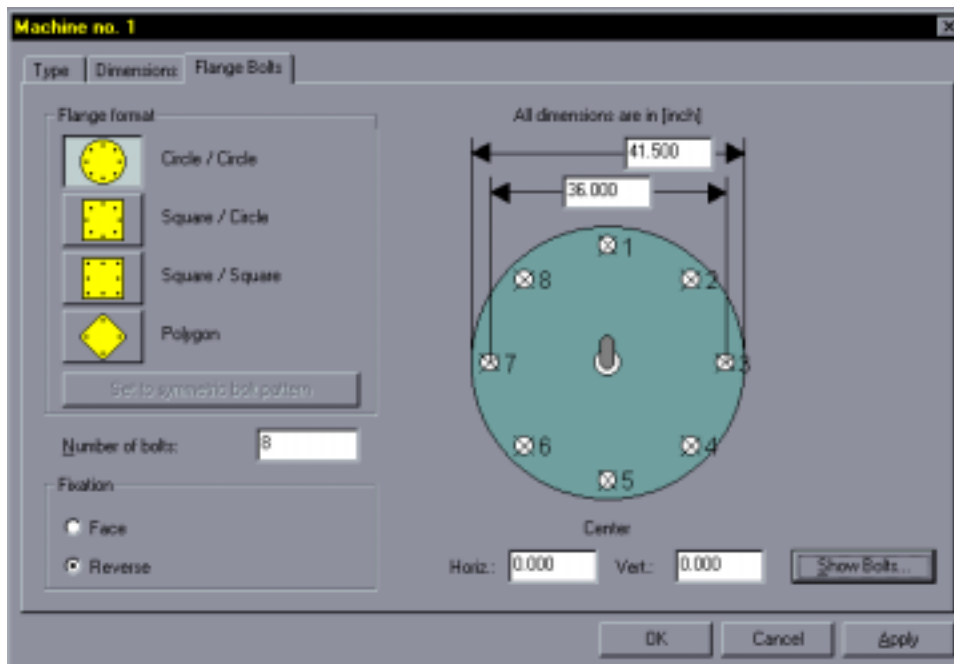
Figure 7

In addition, the exact flange bolt-pattern, flange shape and dimensions were configured, as shown in Figure 7. This capability is believed to be unique to the ROTALIGN® PRO.
